X-38

Test Program Description

The X-38 is a vehicle being developed for crew transfer to support the International Space Station (ISS). The X-38 was once known as an Experimental Crew Return Vehicle (XCRV). It is now simply referred to as a Crew Return Vehicle (CRV). Several series of hypervelocity impact tests have been conducted at the HITF on samples of Thermal Protection Materials (TPS) for the X-38.

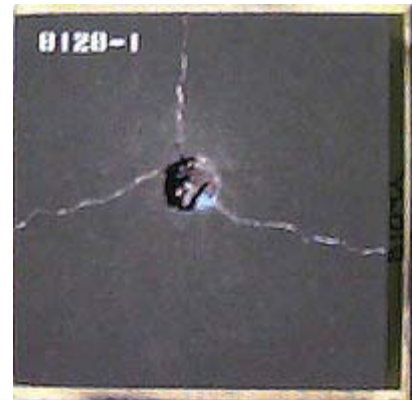
The second X-38 test series addressed the following question: if the X-38 TPS were struck by a projectile not large enough to cause target failure by itself, could subsequent heating during atmospheric entry cause failure at the damaged spot? In this test series, after impact, the targets were subjected to heating at the JSC Arc Jet Laboratory. Once a sufficient number of subpenetrating impacts were achieved for the heating studies, additional impact tests attempting full penetration were conducted.

Subpenetrating projectile sizes used were 3.57 mm (9/64") to 5.56 mm (7/32") against TUF1 tile targets, and 2.8 mm to 3.57 mm (9/64") against AFRSI blanket targets.

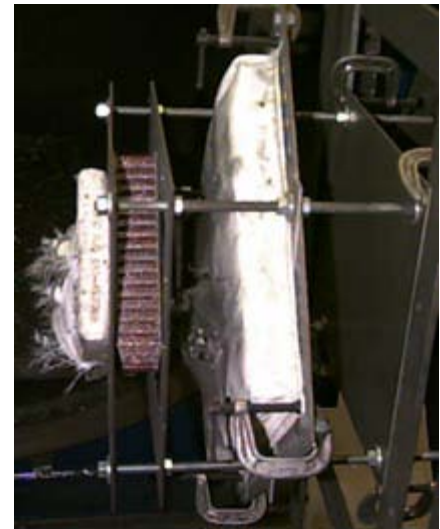
The third X-38 test series was to address a question of Space Station safety. While the X-38 is docked to the ISS, what scale of impact on X-38 TPS materials would not only render the X-38 inoperable, but would threaten Station atmospheric integrity as well? To cause failure in this case, an impact not only had to penetrate the TUFI tile or AFRSI blanket and the honeycomb, it also had to penetrate a thermal insulation pad and a 0.09" (2.29 mm) thick aluminum rear wall representing the ISS pressure hull, or cause spall on that rear wall.

Projectiles up to 1.0 cm in diameter were fired against TUFI tile targets, and projectiles up to 8.73 mm (11/32") in diameter were fired against AFRSI blanket targets. In no case did the rear wall fail. The rear wall was dented in several impacts, but there was never any indication of penetration, cracking, or spall.
